Replace Those Old Tramps

olyester nets on cats and tris have a lifespan of about five to seven years of UV degradation before they need to be replaced, but much shorter if you use Clorox based cleaners on them. In this series of pictures, Etienne Gioire, who supplies replacement tramps through his Company ATN Inc. replaces one on a Privilege 615.

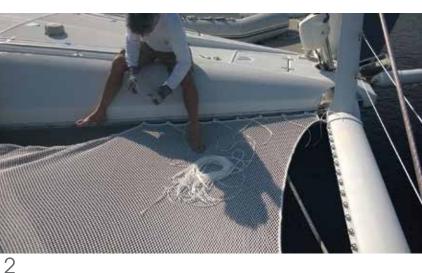
1. The net is 10 percent smaller than the hole and made of Polyamide (polyester) with ½ inch squares. It is attached to the four corners first. This size is the most comfortable size underfoot.

2. The net is lashed with $3/16^{th}$

covered polyester line. And each lashing is separate. Poor installations will simply use a single line along each side but this will fail in months of use. Single lashings are much stronger.

3. The lashing are wrapped three times and then cinched tight. You tighten gradually and then go back and tighten again until the net is stretched to all four edges. A large fid helps to lock the lashing as it is tightened.

4. The job finished properly gives you tramps that will be very firm and will last a long time.
